ECOLOGY SURVEY REPORT

Barn and outbuildings at:

**Lower Daffaluke Farm
Glewstone
HR9 6BB**

September 2021

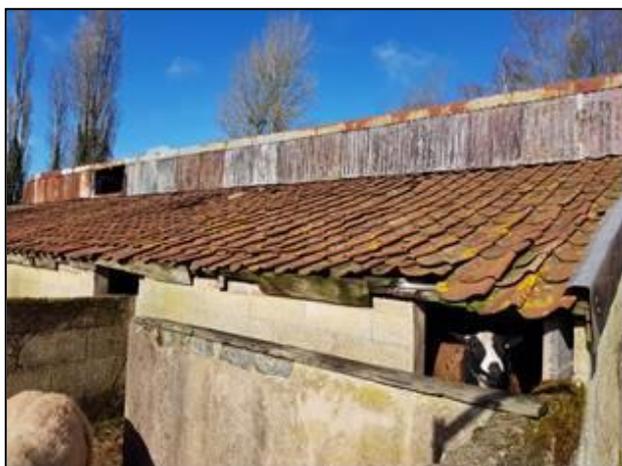
Photo 1 – South roof pitch

The pig sheds building is of concrete block construction with a tiled pitched roof. A pole barn lean-to is attached to the northern side. It is currently used for housing a small number of animals.

There are various cracks and crevices present, but all were either too large to be suitable for use by bats, or contained old cobwebs and debris indicating absence of use. No sign of use by bats were found, and there is negligible potential for such use.

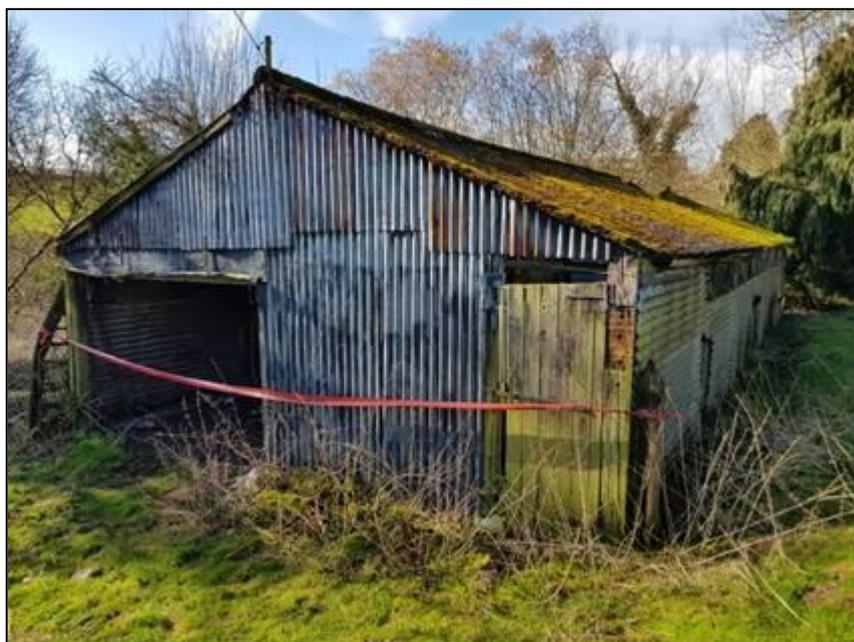
Photo 5 – General view of tin barn

The tin barn is of framed construction with corrugated sheet wall and roof coverings. It is largely disused.

There are no cracks and crevices suitable for use by bats present. No sign of use by bats were found, and there is negligible potential for such use.

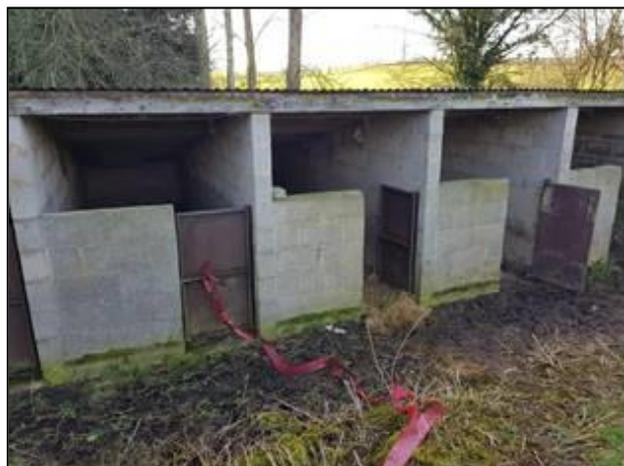
Photo 6 – Block sheds north aspect

The block sheds are of concrete block construction with corrugated sheet roof coverings. They are disused.

There are no cracks and crevices suitable for use by bats present. No sign of use by bats were found, and there is negligible potential for such use.

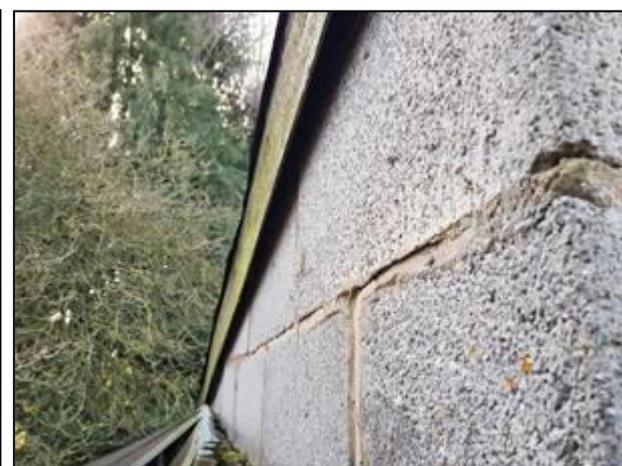
Photo 9 – Gaps unsuitable / debris-filled at verges

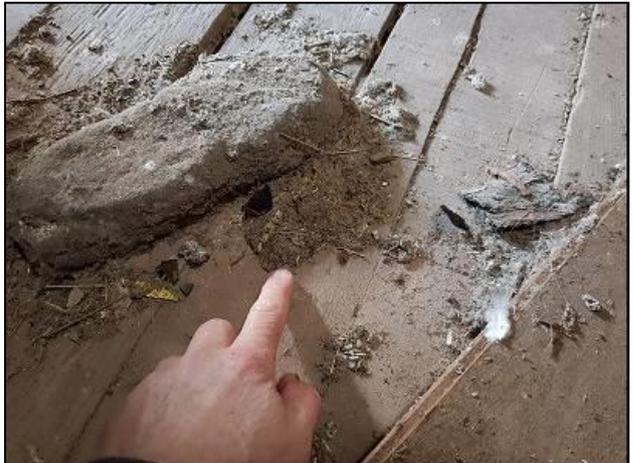
Internally, there are various gaps and crevices between masonry and structural timber elements suitable for potential use by bats. A very light scattering of butterfly wing feeding remains and bat droppings consistent with *plecotus sp.* bat origin was present on the floor of the first floor rooms only.

Photo 19 – Bat feeding remains - first floor

It is recommended that replacement roosting facility is provided by the installation of self-contained bat roosting boxes suitable for the pipistrelle and long-eared bats. These will be permanently installed on the walls of the converted barn.

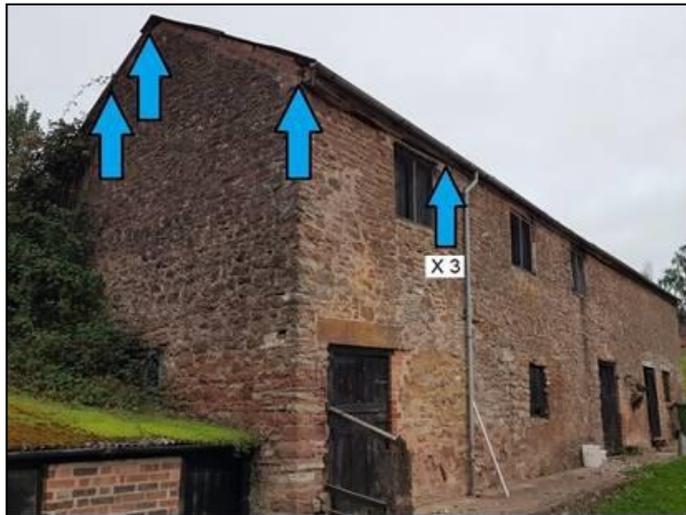
Photo 20

Bat activity was surveyed from 15 minutes before sunset. Between 21:03 and 21:34hrs, seven common and soprano pipistrelles **emerged** from the building at the locations shown below:

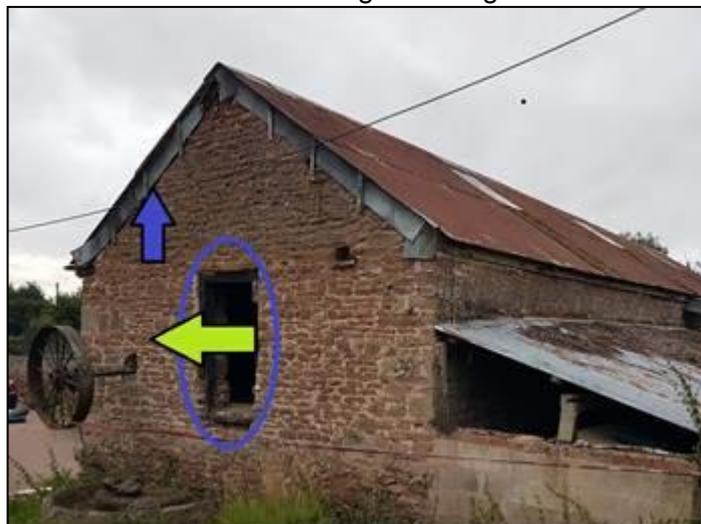
Photo 21

Two unidentified bats emerged through the north door:

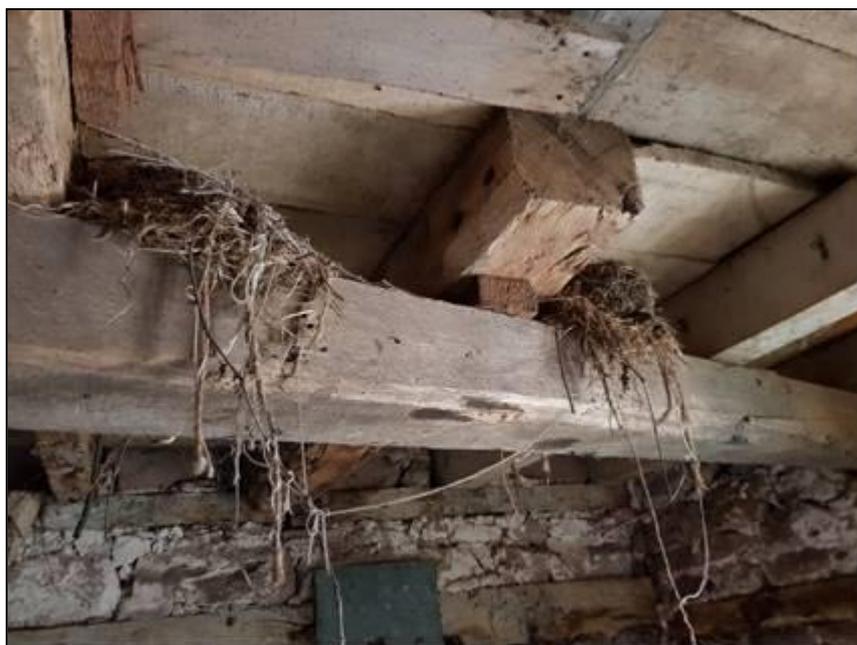
During the visits to the buildings, two old and two more recently used nests were found within the main barn.

Whilst no active nesting was found to confirm species, these all appeared to be blackbird nests, with one adapted by robin or wren.

Photo 23 – Blackbird nests in main barn ground floor

The species nesting within the barn are nationally common and widespread, and neither is of general conservation concern. On that basis, compensation for replacement nesting sites is not considered necessary.
